Balancing Adaptation and Legacy: How the Washington National Cathedral is Protecting its Olmsted Woods in the Era of Climate Change

Martha Eberle, PLA, ASLA, Andropogon Associates, Raleigh, North Carolina
Scott Todd, PLA, Morris Arboretum, Philadelphia, Pennsylvania

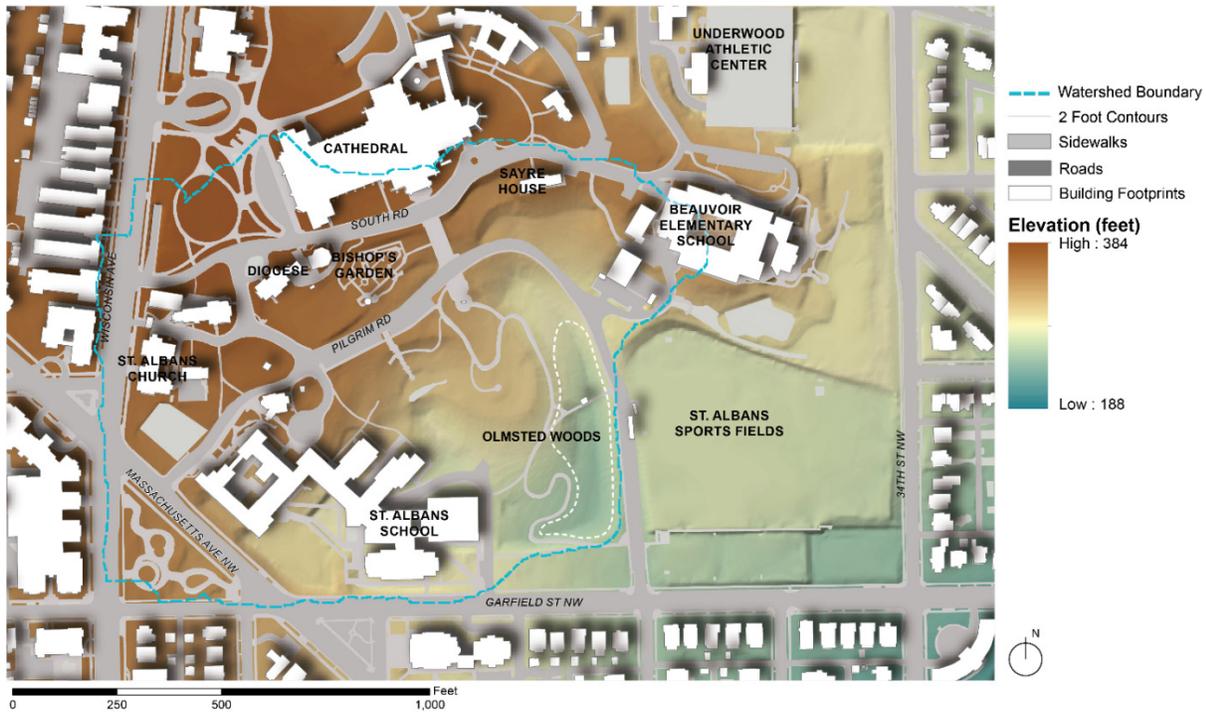
Figure 2. Elevation map of the Olmsted Woods watershed within the Cathedral Close; Image: Andropogon

Olmsted Woods encompasses five acres of woodland in the southern portion of the 59-acre Close of the Washington National Cathedral, which is located in the northwestern part of D.C., near the Naval Observatory and Embassy Row. Two streams within Olmsted Woods drain a 26-acre watershed, encompassing the southern half of the Close, a portion of the Cathedral building itself, St. Albans school, All Hallows Amphitheater, the Bishop’s Garden, and a portion of Beauvoir Elementary school. Almost all of the Cathedral grounds are within the watershed of Rock Creek, a beloved but damaged stream system that suffers from the typical suite of urban

water quality problems. Water drains from Olmsted Woods to the southeast and connects to Rock Creek via a stream system traversing nearby Normanstone Park.

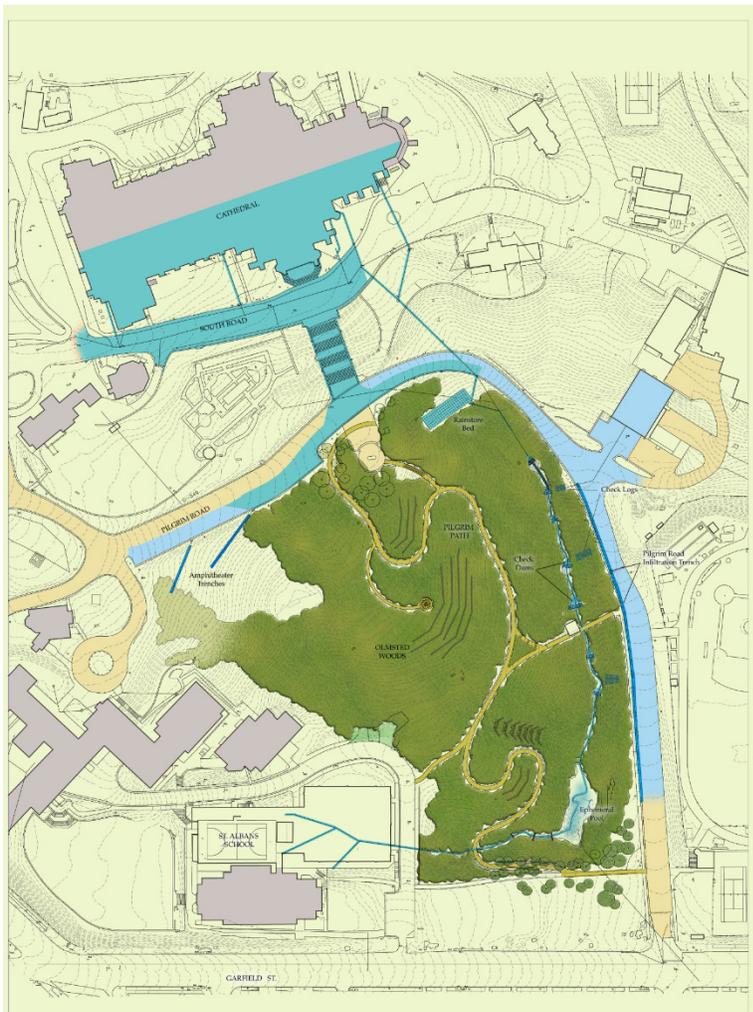
Figure 4. Stormwater diagram from Andropogon's 2000 Master Plan; Image: Andropogon

Soil tests located suitable sites where water could be taken out of pipes, captured in infiltration trenches, and used to water the new plantings installed on woodland slopes. Boulders and cedar logs were slid into the ravines on specially made conveyors for the construction of in-stream check dams and check logs. A RainStore storage bed was installed at the head of a ravine to capture water from the Cathedral roof and slowly release the flows into the channel to feed an ephemeral pool. Phased installation of native woodland plantings also helped to gradually restore the native forest structure.

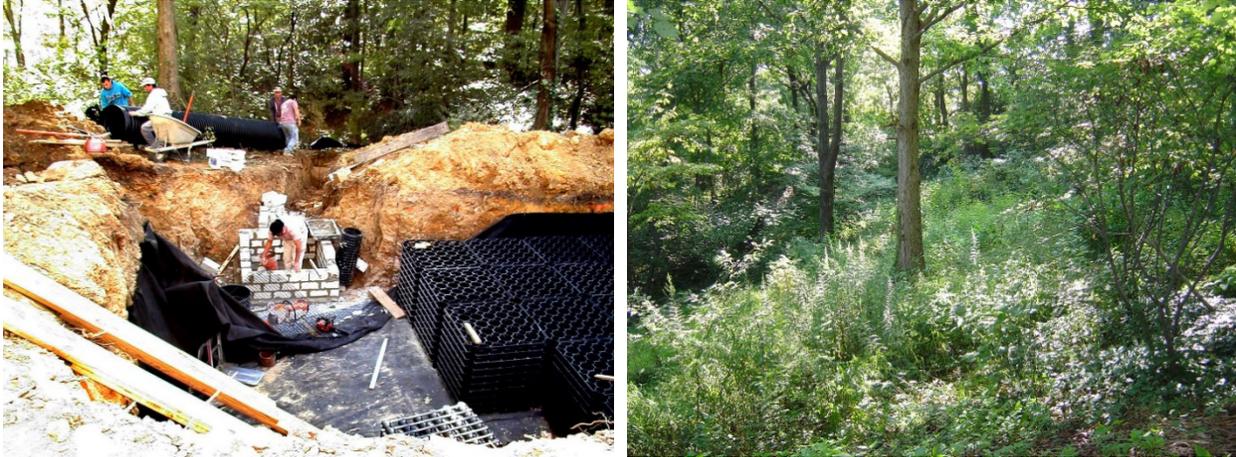
Figure 5. RainStore stormwater detention device during installation in 2003 (left), and the same location in 2005 (right); Photos: Andropogon

As part of Andropogon's Integrative Research practice, the team will monitor the performance of previously installed stormwater treatment devices, including an underground detention system and infiltration trenches within Pilgrim Road. The team has engaged Invisible Structures, the manufacturer of the RainStore stormwater detention system (the first of its kind when it was installed in 2002) to help provide monitoring equipment that will help the team understand what impact the structure has had, as well as what maintenance or repairs may be necessary.

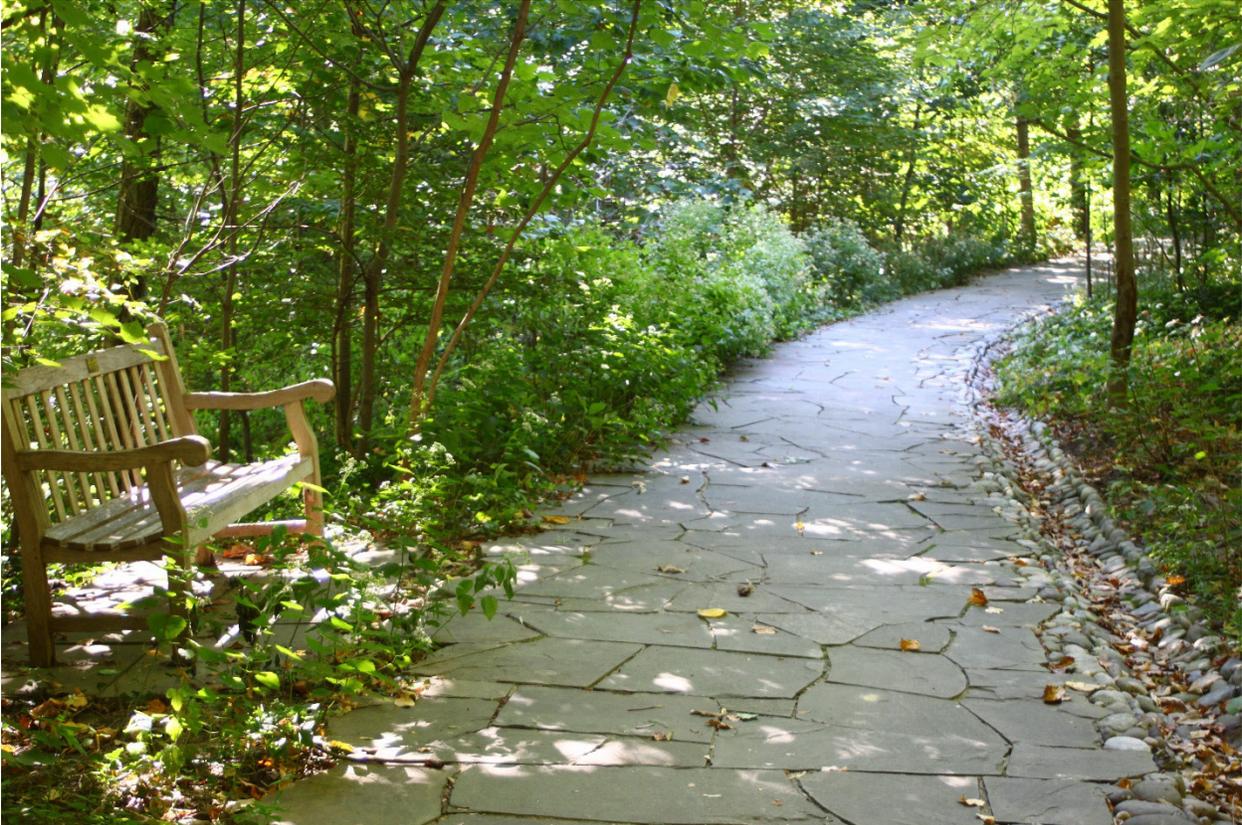
Figure 6. Stabilized path materials and stone stormwater swales continue to help manage runoff from the Pilgrim's Path (2017); Photo: Andropogon

The team also formalized the “Pilgrim’s Path” as a stone footpath, which provides access to the main building from the south in keeping with Olmsted’s original vision. The path was carefully threaded through the woods to improve visitor access while minimizing impacts. Tree root aeration measures and stormwater infiltration pits built during path construction remained in place as part of the permanent woodland restoration program. Quiet, contemplative seating areas were also added as part of the path improvements, and these areas have become favorites for local birders.

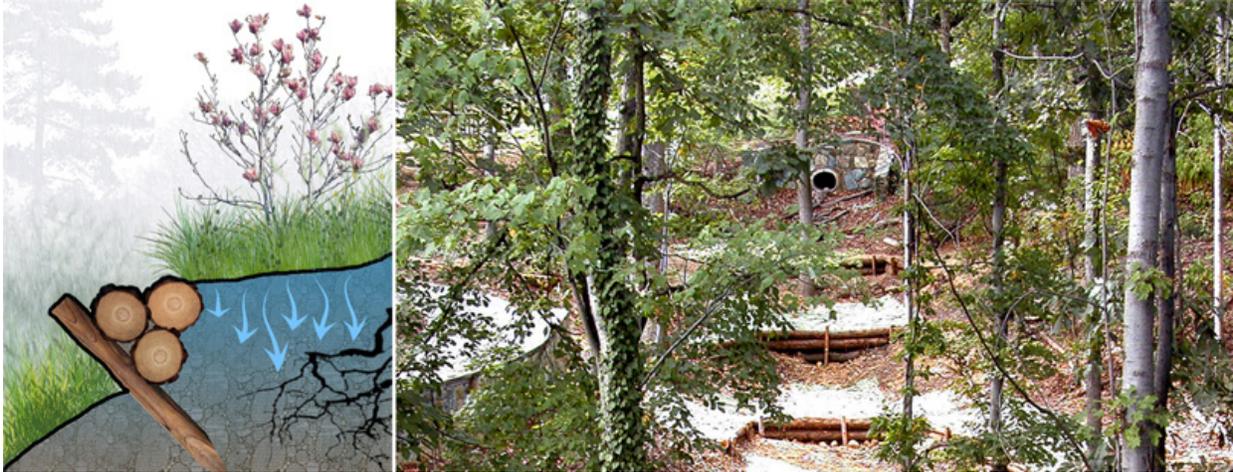
Figure 7. Section diagram of log check dams (left), and after 2002 installation in Olmsted Woods (right): Image & photo: Andropogon

The team found that the check dams have performed well and allowed the stream bed to stabilize, but they are in need of repairs and additional structural supports. In order to slow and treat the stormwater entering the Woods, the design team recommended the following interventions:

- Continue to stabilize the existing steep slopes, particularly in areas where stormwater enters the ravine, by planting native groundcover plants (seeding or landscape plugs) in conjunction with soil bioengineering techniques, such as live staking, live fascines, brushlayering, and branchpacking.
- In areas where scouring and undercutting are occurring in the stream channel, stabilize banks by shoring up or expanding existing check dams. Check logs can be replaced or added.

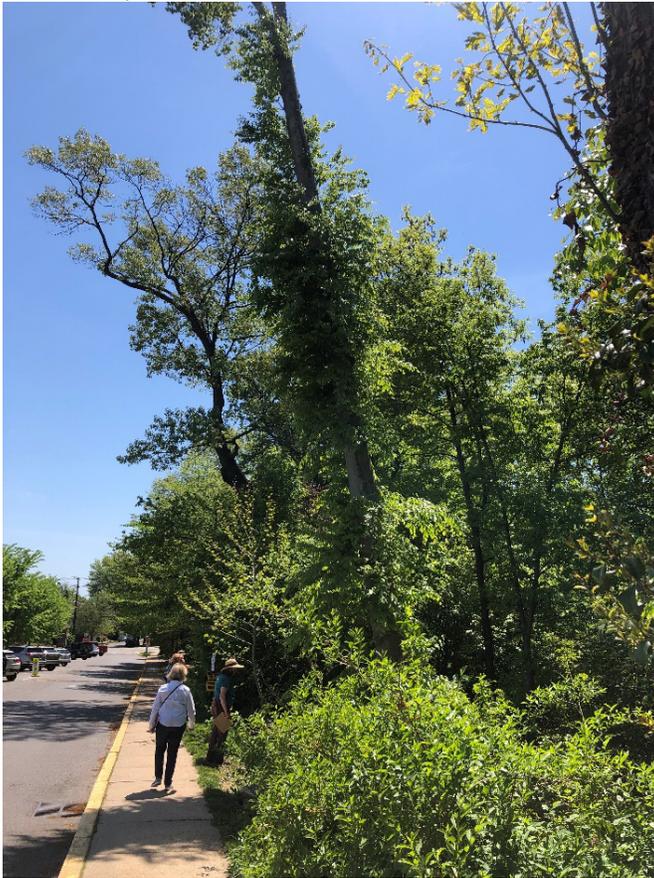
Figure 8. Stressed trees and major gaps in canopy due to tree loss on east side of ravine (2021); Photo: Andropogon

The UF tree inventory included 77 oaks, and many of these were declining more than expected for their age, position in the landscape, and environmental conditions. In research and discussions with state and national forest managers, oak decline has been evident throughout Mid-Atlantic region during the past few years. Oak decline refers to a progressive dieback and eventual mortality of oak trees. It is believed to be often triggered by drought. The National Park Service's National Capital Area office reports the following regarding oak decline:

Symptoms include early browning of leaves, thinning of canopy cover, and loss of branches, which can eventually lead to tree mortality. Understanding and preventing this phenomenon has been challenging, given that no single factor is responsible for what is generally defined as Oak Decline. A host of stressors including climate, tree age, site conditions, and history of disease interact to weaken trees over time, ultimately leading to sudden death when the tree's resources are exhausted . . . In the National Capital Area, Armillaria root rot fungus, two-lined chestnut borer beetle (*Agrilus bilineatus*), and bacterial leaf scorch (caused by *Xylella fastidiosa*) are commonly blamed for killing oaks, even though they typically only attack trees that
